The Road Inventory of Camas National Wildlife Refuge Hamer, ID

Prepared By:
Federal Highway Administration
Central Federal Lands Highway Division
April 2013

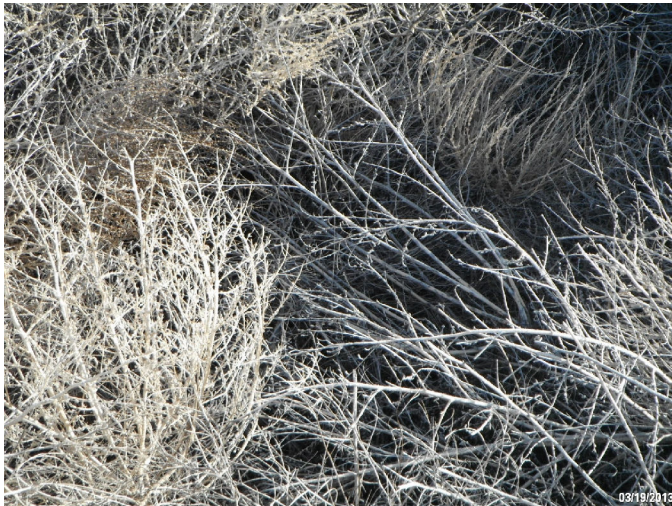
Photo: CAMA_C4_0571 Route: 409-001-0.79

Metal WCS Flashboard Riser 20ft long 36in dia. 2ft deep

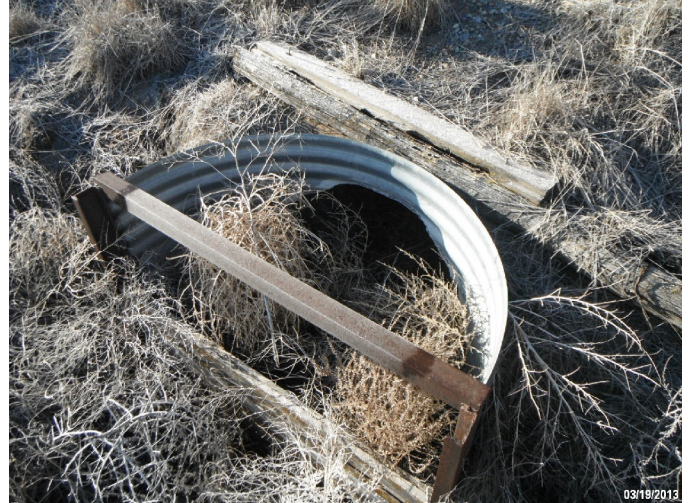
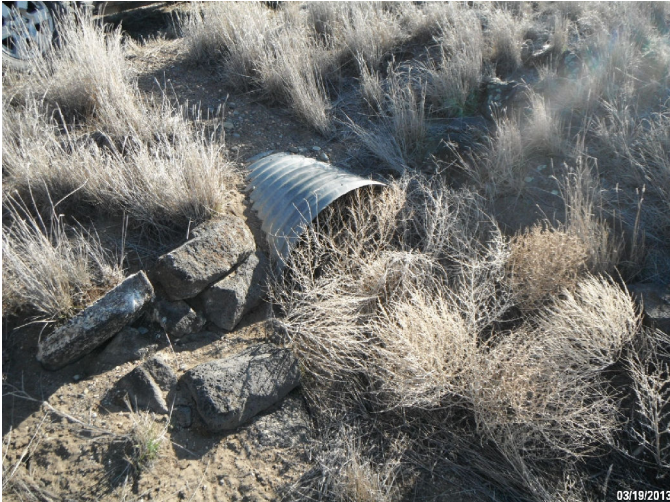
Photo: CAMA_C4_0573 Route: 410-001-0.21
Metal WCS Flashboard Riser 30ft long 36in dia. 1ft deep

Photo: CAMA_C4_0574 Route: 410-001-0.21
Metal WCS Flashboard Riser 30ft long 36in dia. 1ft deep

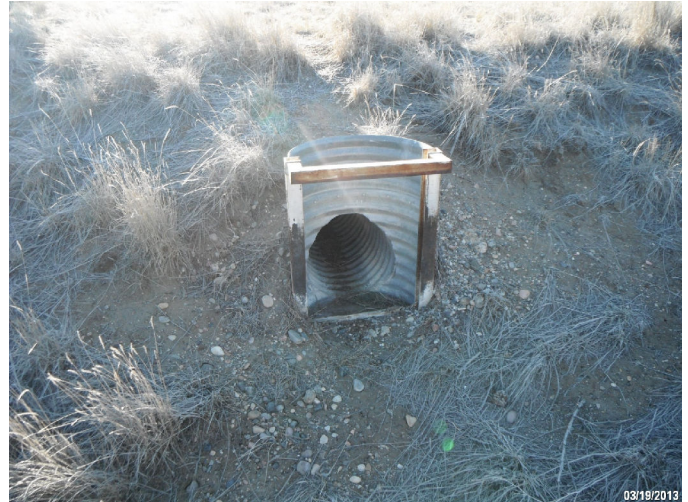
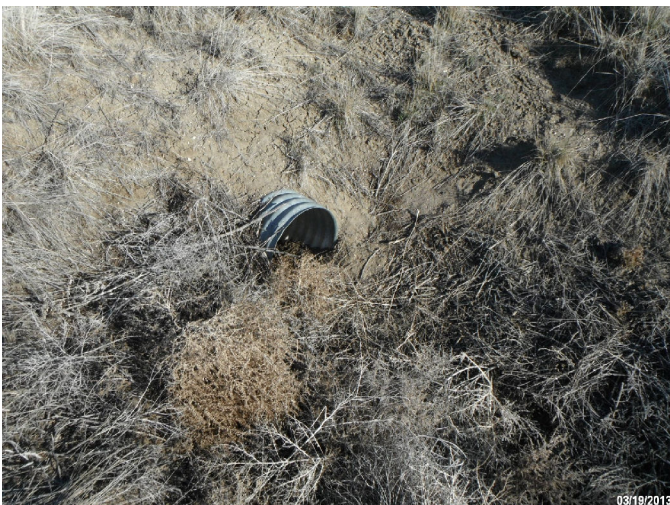
Photo: CAMA_C4_0575 Route: 410-001-0.28
Metal WCS Flashboard Riser 40ft long 18in dia. 3ft deep

Photo: CAMA_C4_0576 Route: 410-001-0.28
Metal WCS Flashboard Riser 40ft long 18in dia. 3ft deep

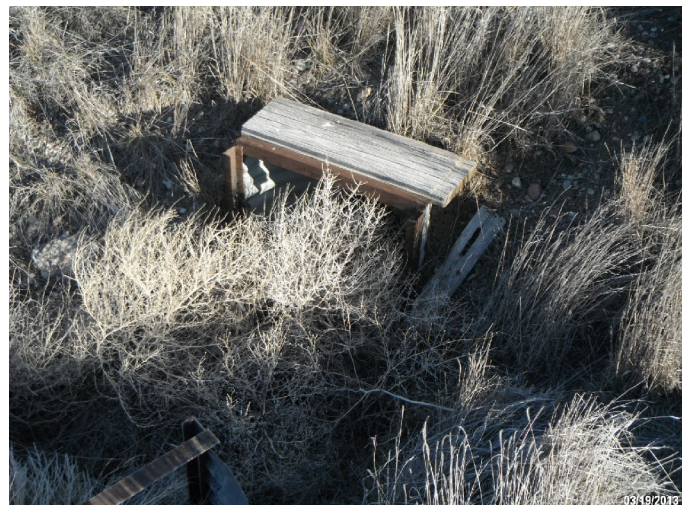
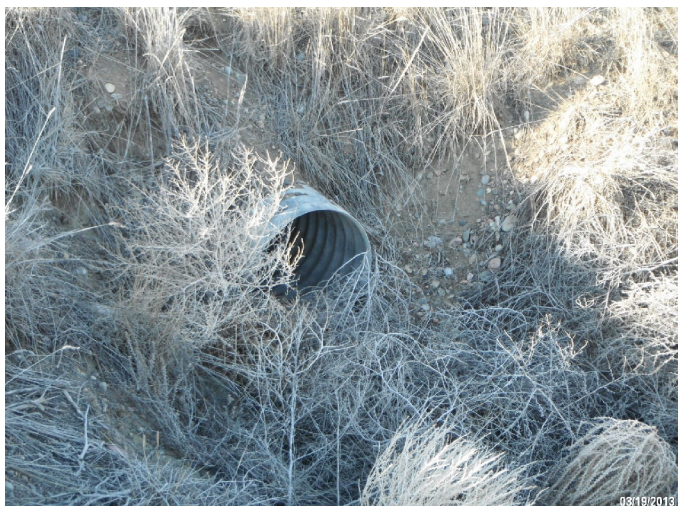
Photo: CAMA_C4_0577 Route: 410-001-0.6
Metal WCS Flashboard Riser 20ft long 24in dia. 4ft deep
8-030

Photo: CAMA_C4_0578 Route: 410-001-0.6
Metal WCS Flashboard Riser 20ft long 24in dia. 4ft deep

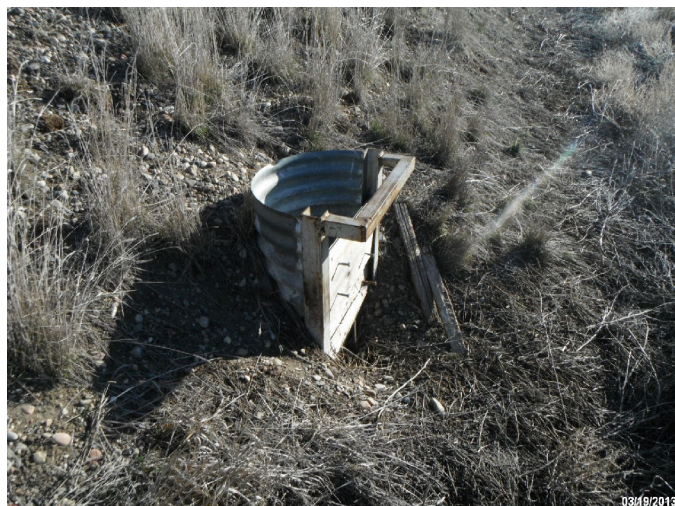
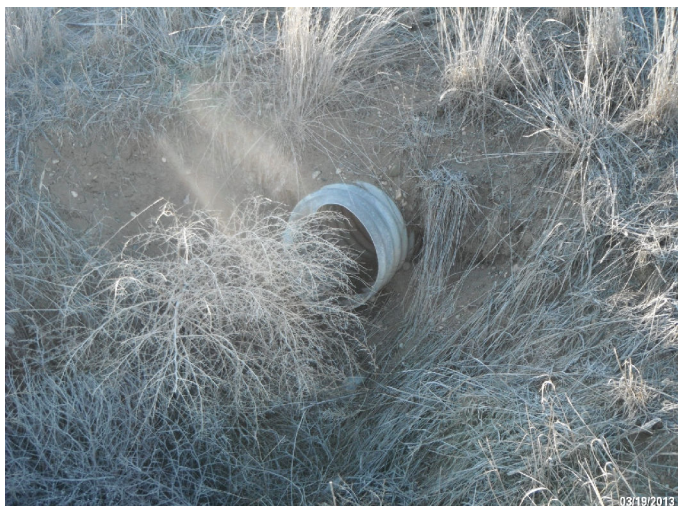
Photo: CAMA_C4_0579 Route: 410-001-0.69
Metal WCS Flashboard Riser 30ft long 24in dia. 5ft deep

Photo: CAMA_C4_0580 Route: 410-001-0.69
Metal WCS Flashboard Riser 30ft long 24in dia. 5ft deep

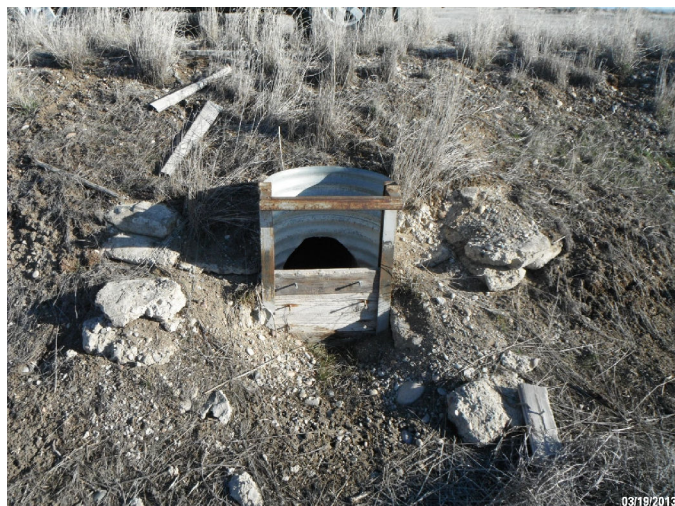
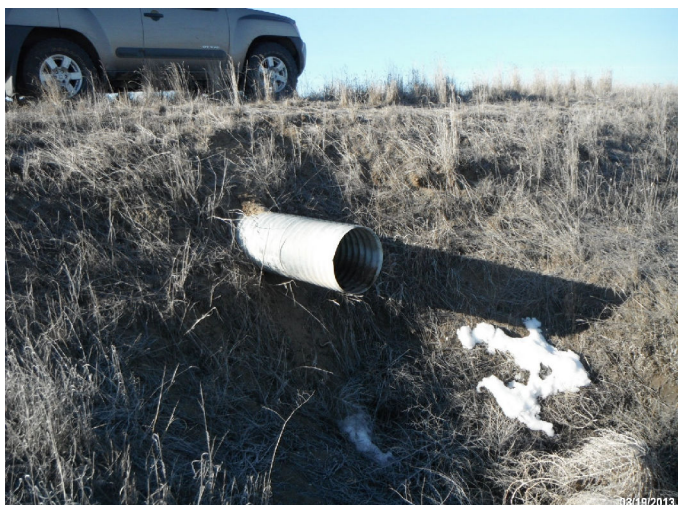
Photo: CAMA_C4_0581 Route: 410-001-0.84
Metal WCS Flashboard Riser 40ft long 24in dia. 4ft deep

Photo: CAMA_C4_0582 Route: 410-001-0.84
Metal WCS Flashboard Riser 40ft long 24in dia. 4ft deep

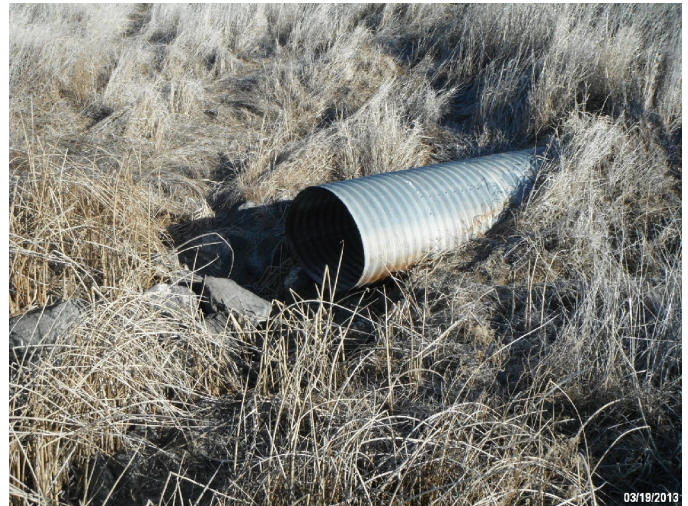
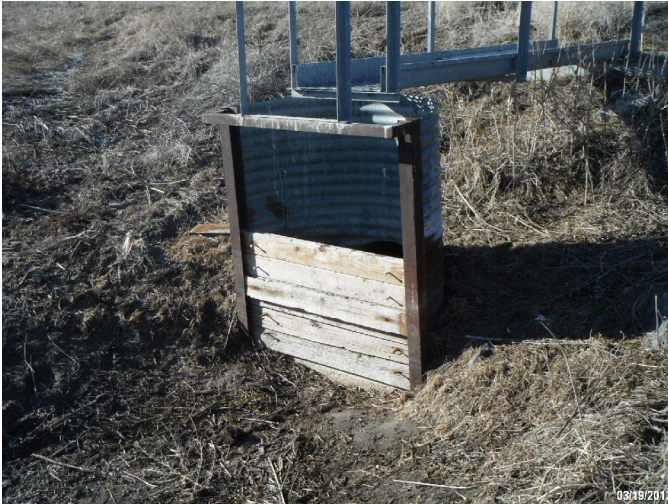
Photo: CAMA_C4_0596 Route: 411-001-0.1
Metal WCS Flashboard Riser 50ft long 36in dia. 4ft deep

Photo: CAMA_C4_0597 Route: 411-001-0.1
Metal WCS Flashboard Riser 50ft long 36in dia. 4ft deep

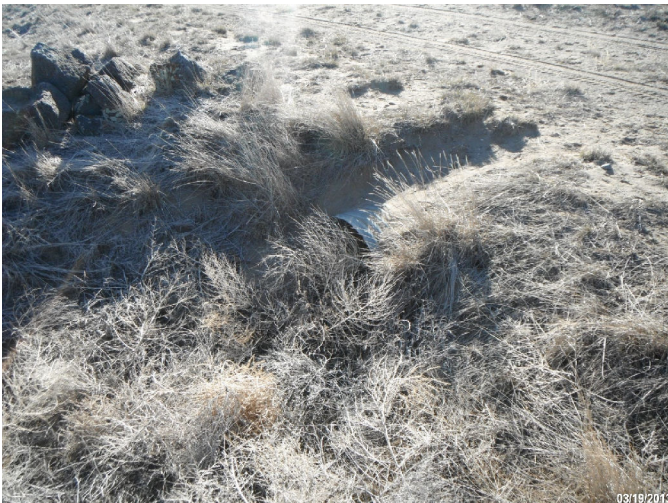
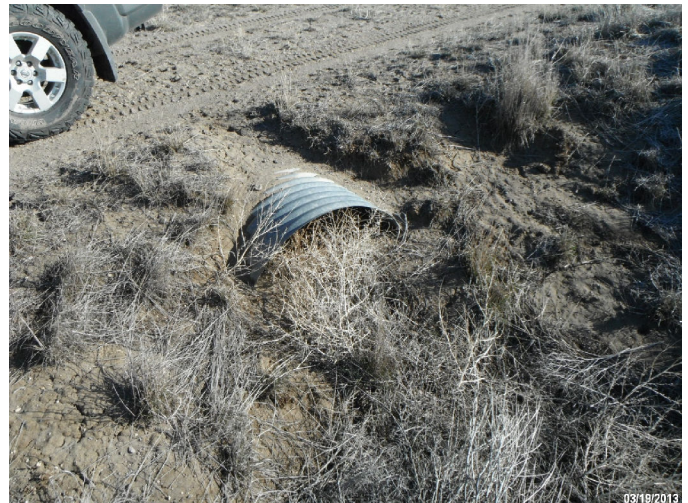
Photo: CAMA_C4_0593 Route: 411-002-1.54
Metal Culvert 30ft long 36in dia. 1ft deep

Photo: CAMA_C4_0594 Route: 411-002-1.54
Metal Culvert 30ft long 36in dia. 1ft deep

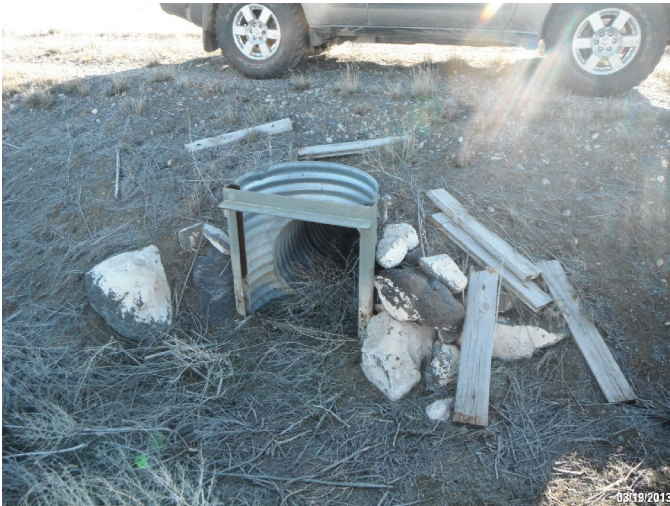
Photo: CAMA_C4_0589 Route: 411-003-1.91
Metal WCS Flashboard Riser 20ft long 24in dia. 3ft deep

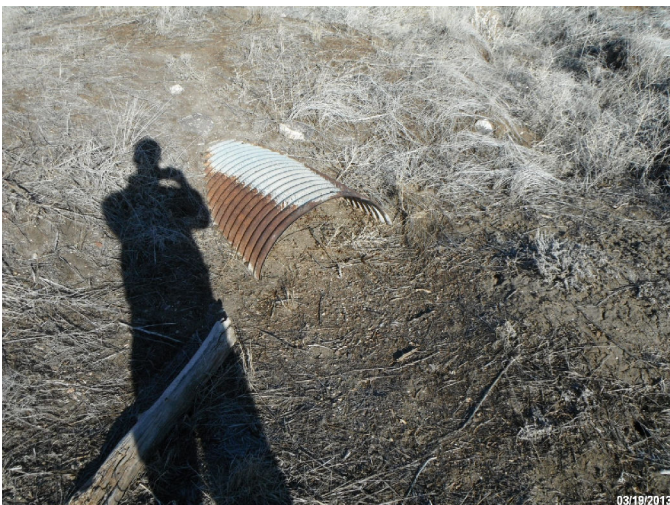
Photo: CAMA_C4_0591 Route: 411-003-1.91
Metal WCS Flashboard Riser 90ft long 36in dia. 7ft deep

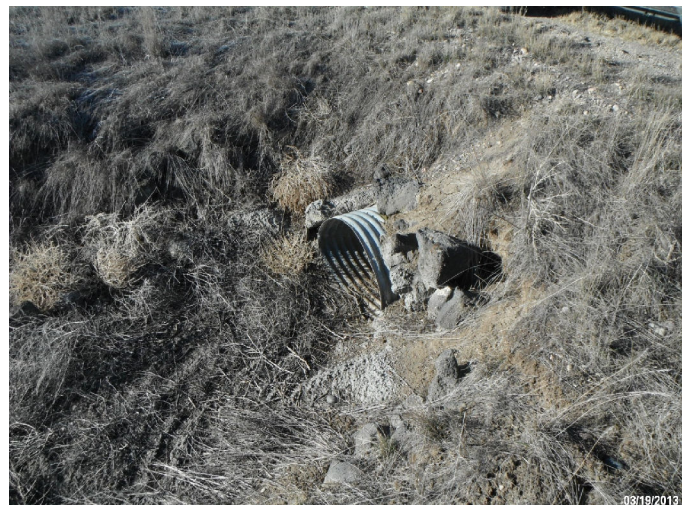
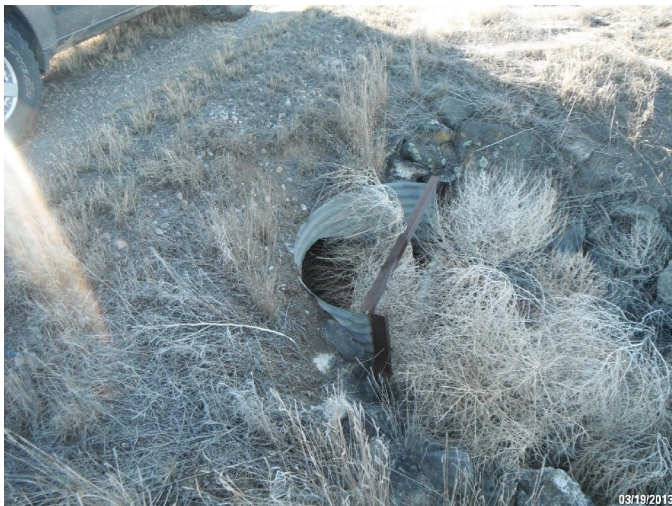
Photo: CAMA_C4_0586 Route: 411-003-2.41
Metal WCS Flashboard Riser 20ft long 36in dia. 3ft deep
8-033

Photo: CAMA_C4_0587 Route: 411-003-2.41
Metal WCS Flashboard Riser 20ft long 36in dia. 3ft deep

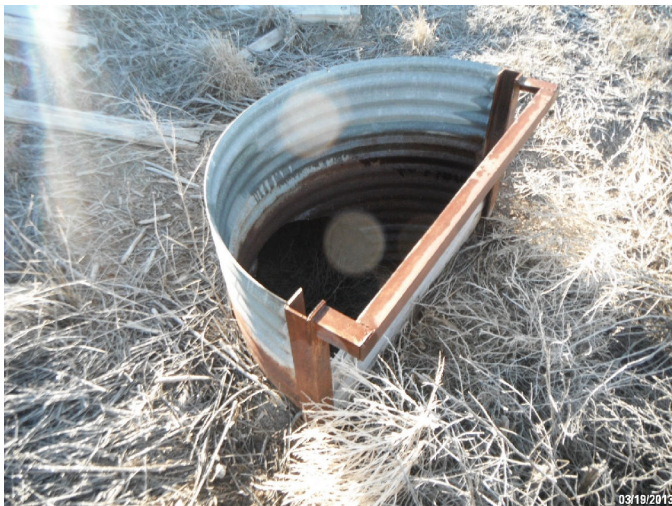
Photo: CAMA_C4_0585 Route: 411-003-2.49
Metal WCS Flashboard Riser 90ft long 36in dia. 4ft deep

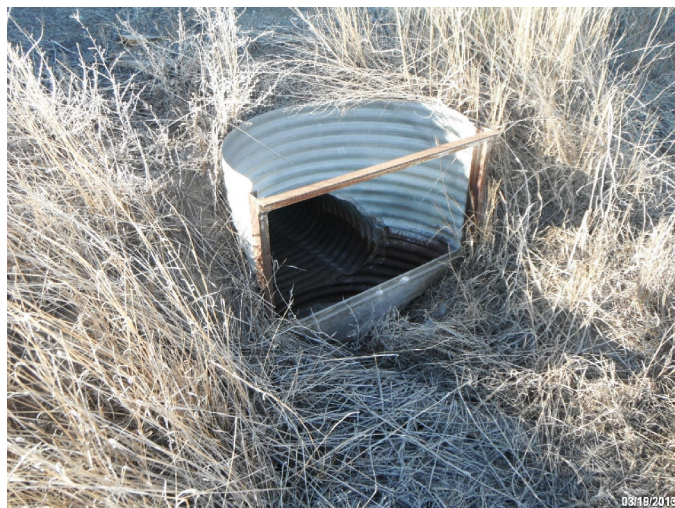
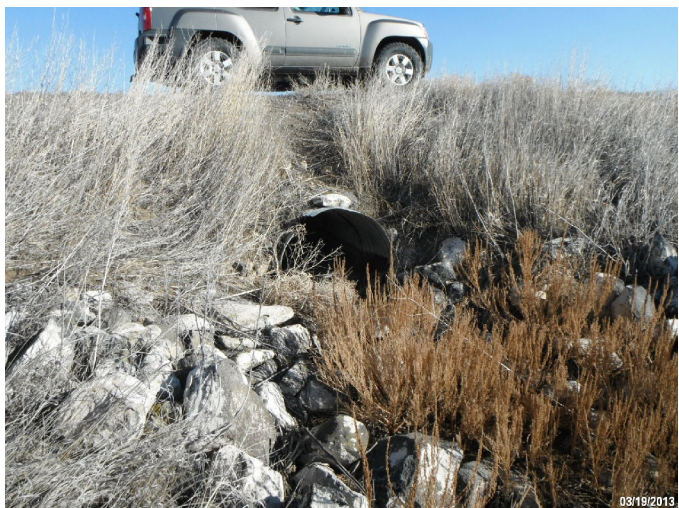
Photo: CAMA_C4_0600 Route: 412-001-0.34
Metal WCS Flashboard Riser 20ft long 36in dia. 3ft deep

Photo: CAMA_C4_0601 Route: 412-001-0.34
Metal WCS Flashboard Riser 20ft long 36in dia. 3ft deep

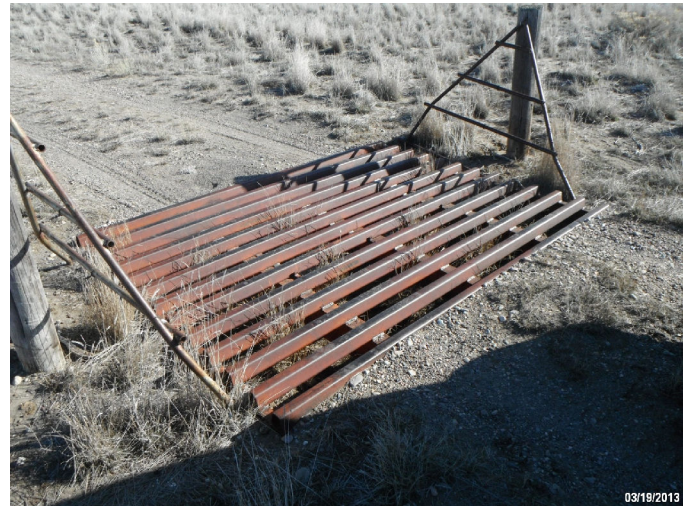
Photo: CAMA_C4_0603 Route: 413-001-0.21
Metal Cattle Guard

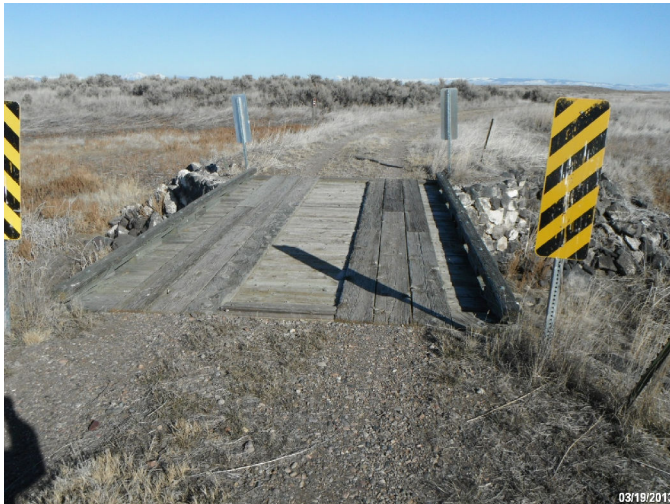
Photo: CAMA_C4_0604 Route: 413-001-0.72
Wood Bridge NBIS:NA
See CAMA_C4_0605, CAMA_C4_0606

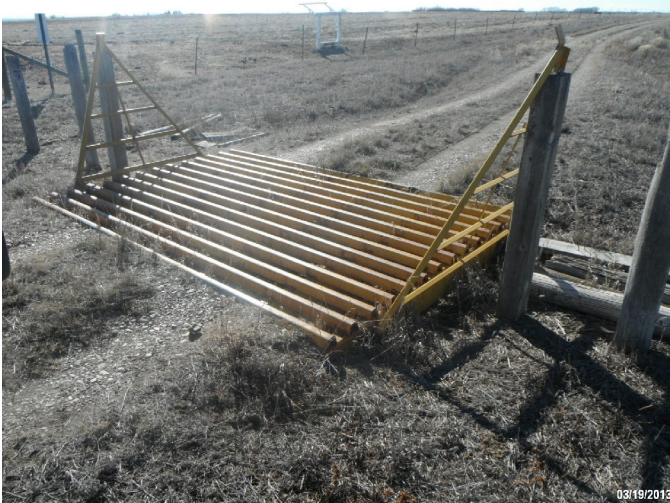
Photo: CAMA_C4_0615 Route: 413-004-2.69
Metal Cattle Guard

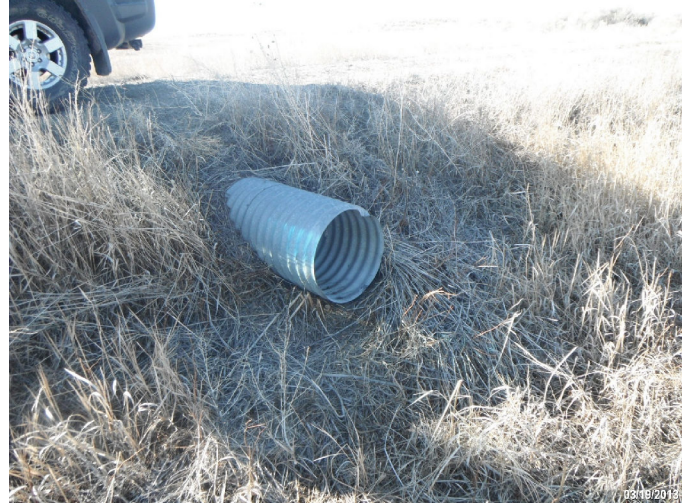
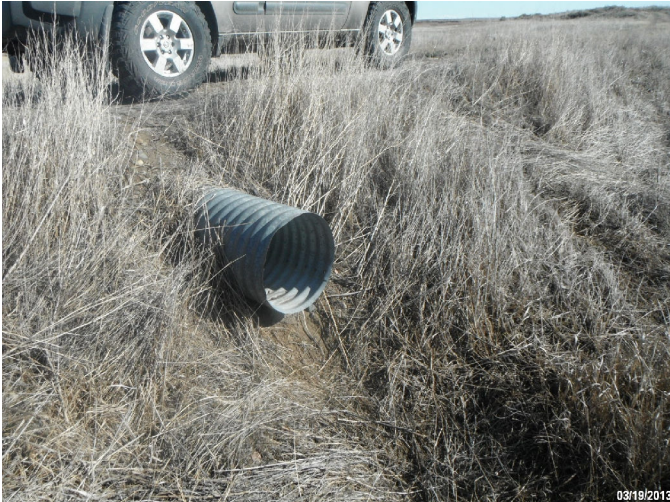
Photo: CAMA_C4_0616 Route: 413-004-2.81
Metal Culvert 20ft long 18in dia. 2ft deep

Photo: CAMA_C4_0617 Route: 413-004-2.81
Metal Culvert 20ft long 18in dia. 2ft deep

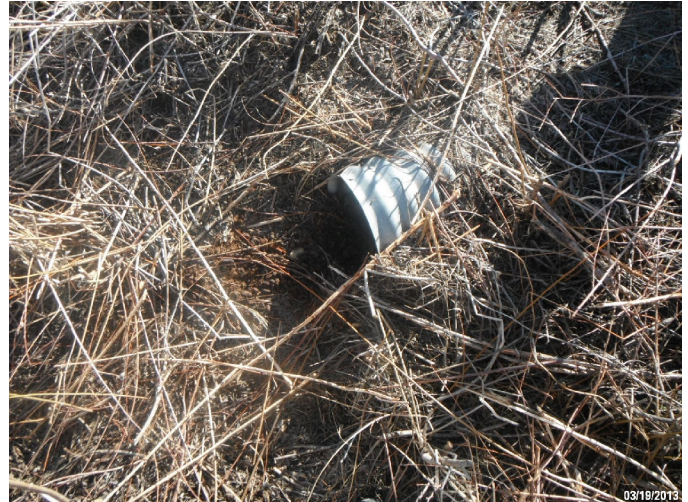
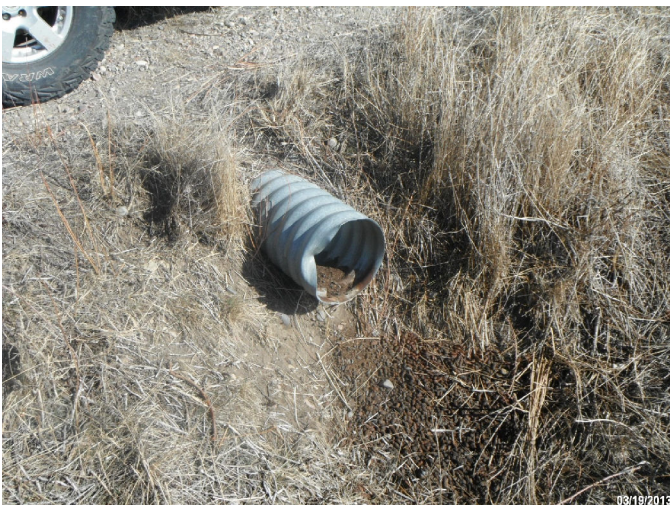
Photo: CAMA_C4_0618 Route: 413-004-3.36
Metal Culvert 20ft long 12in dia. 1ft deep

Photo: CAMA_C4_0619 Route: 413-004-3.36
Metal Culvert 20ft long 12in dia. 1ft deep

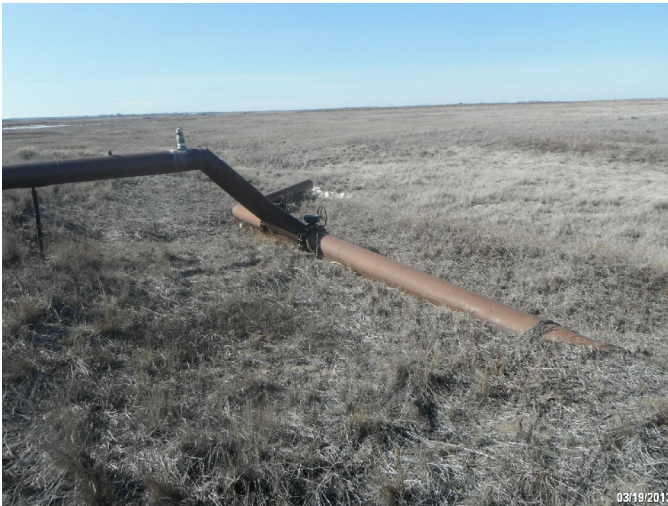
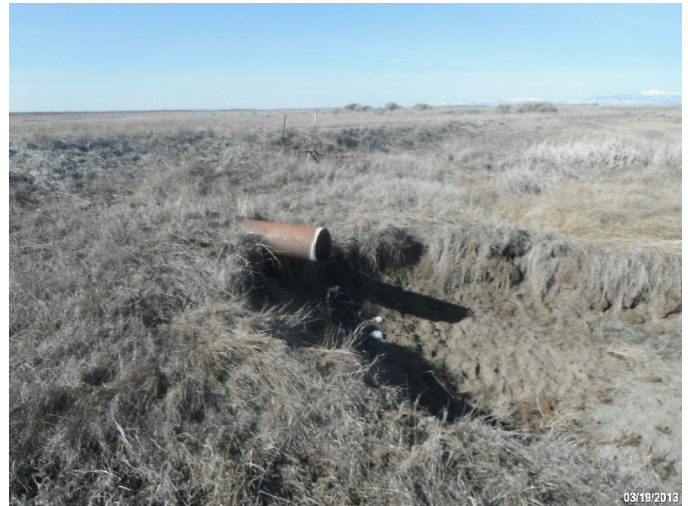
Photo: CAMA_C4_0621 Route: 413-005-4.28
Metal WCS Other 90ft long 18in dia. 3ft deep

Photo: CAMA_C4_0622 Route: 413-005-4.28
Metal WCS Other 90ft long 18in dia. 3ft deep

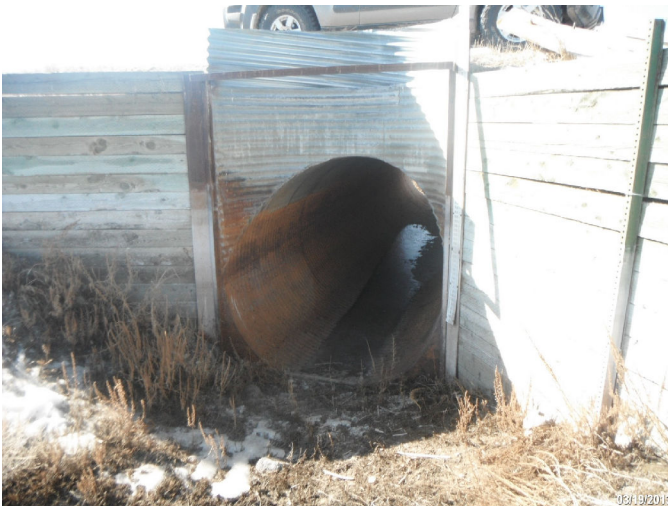
Photo: CAMA_C4_0623 Route: 413-005-4.43
Metal WCS Flashboard Riser 25ft long 70in dia. 3ft deep

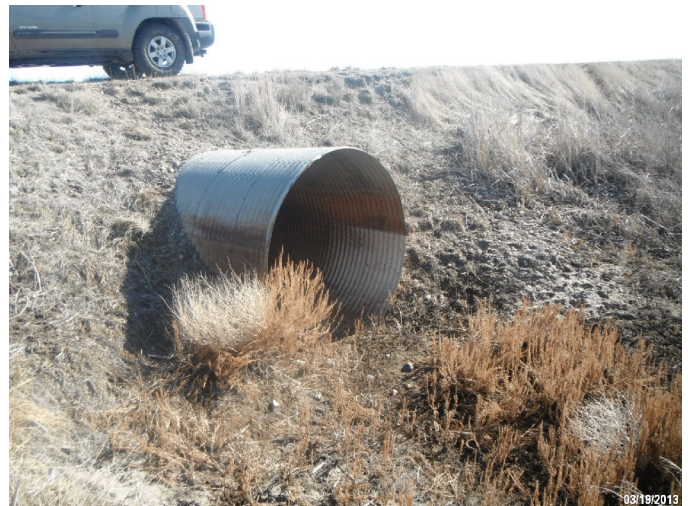
Photo: CAMA_C4_0624 Route: 413-005-4.43
Metal WCS Flashboard Riser 25ft long 70in dia. 3ft deep

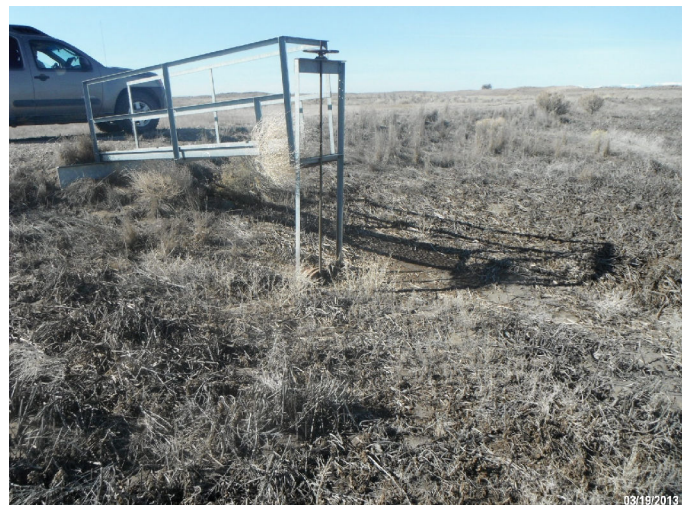
Photo: CAMA_C4_0626 Route: 413-006-5.02
Metal WCS Screw Gate 50ft long 24in dia. 4ft deep

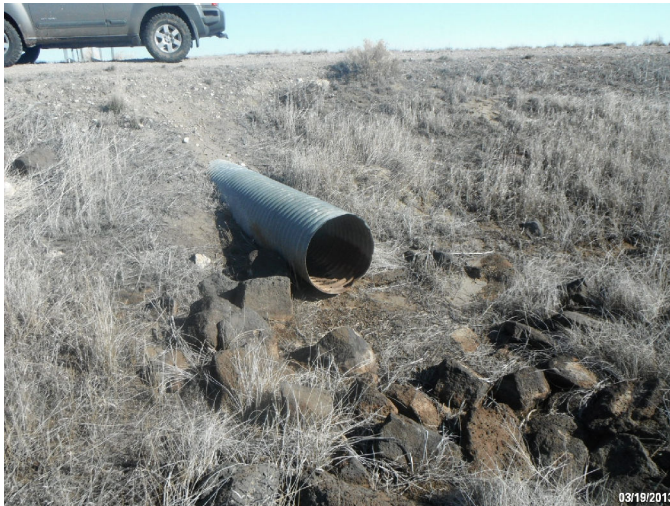
Photo: CAMA_C4_0627 Route: 413-006-5.02
Metal WCS Screw Gate 50ft long 24in dia. 4ft deep

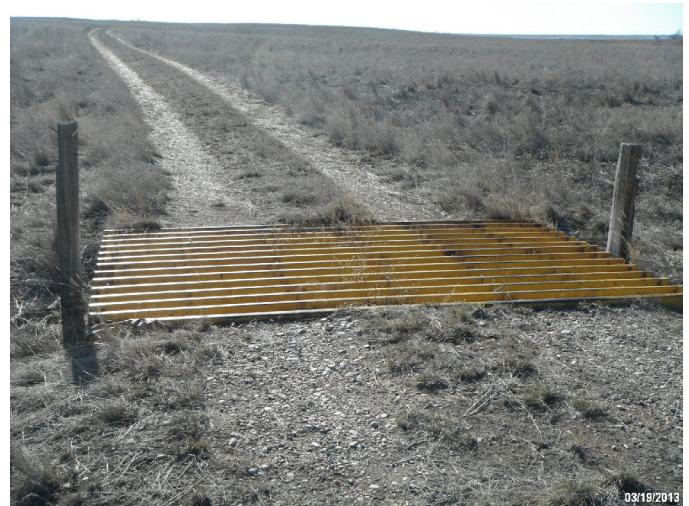
Photo: CAMA_C4_0609 Route: 414-001-0.01
Metal Cattle Guard

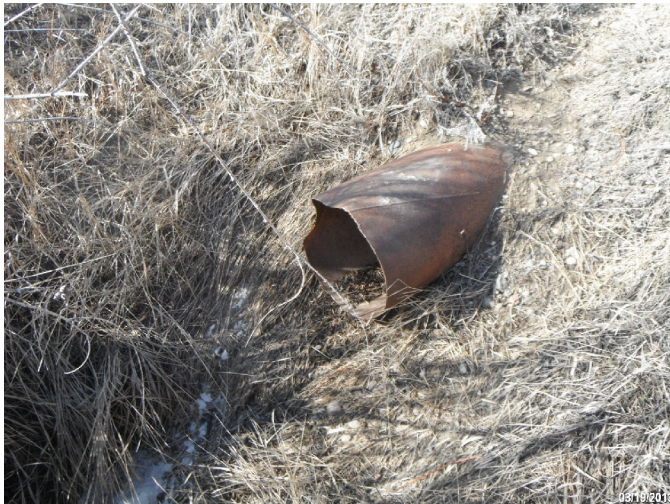
Photo: CAMA_C4_0610 Route: 414-001-0.53
Metal Culvert 20ft long 18in dia. 1ft deep

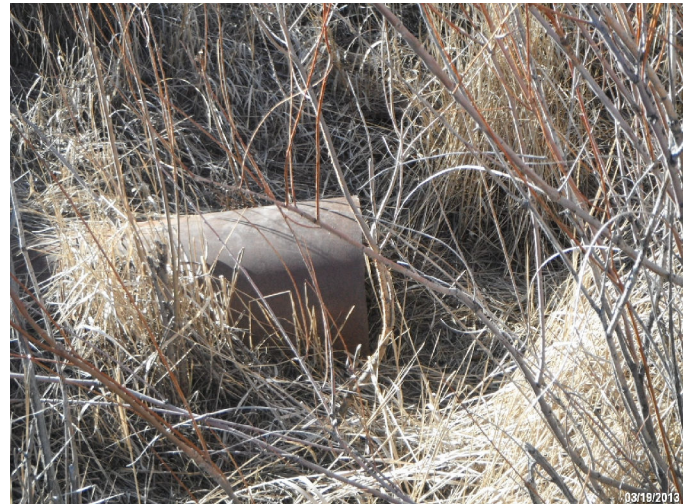
Photo: CAMA_C4_0611 Route: 414-001-0.53
Metal Culvert 20ft long 18in dia. 1ft deep

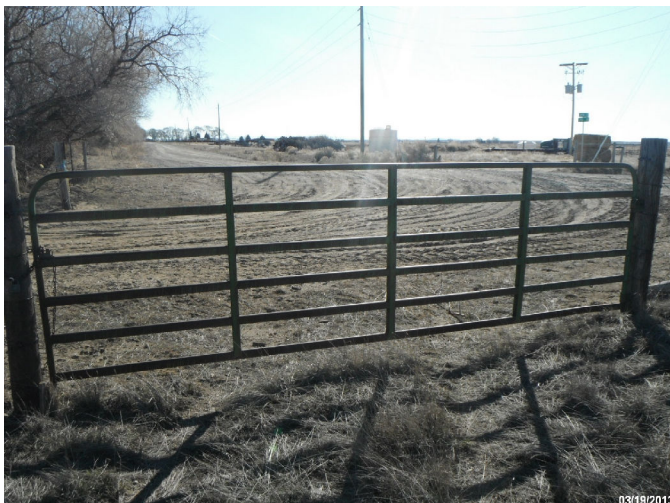
Photo: CAMA_C4_0612 Route: 414-001-0.8
Metal Open Rail Gate

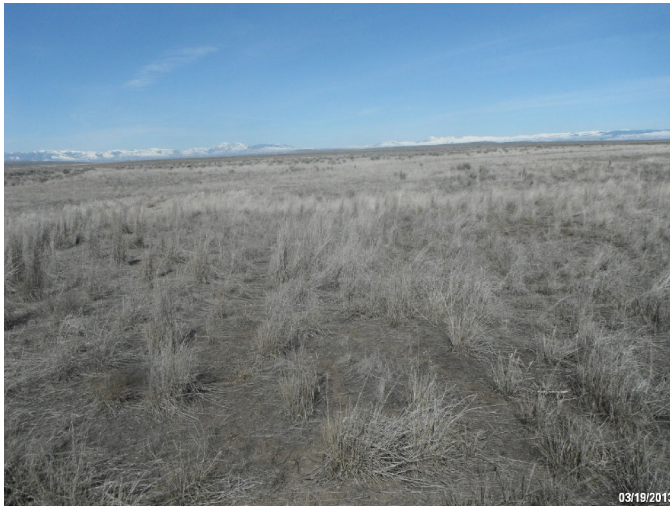
Photo: CAMA_C4_0646 Route: 600-001-0.01
Problem Area Location of Main Diversion West to NE
Corner Lair Field Road. Asset # 10064359 Could not locate
road
